## Tricks of the Trade

### Dave Porter G4OYX

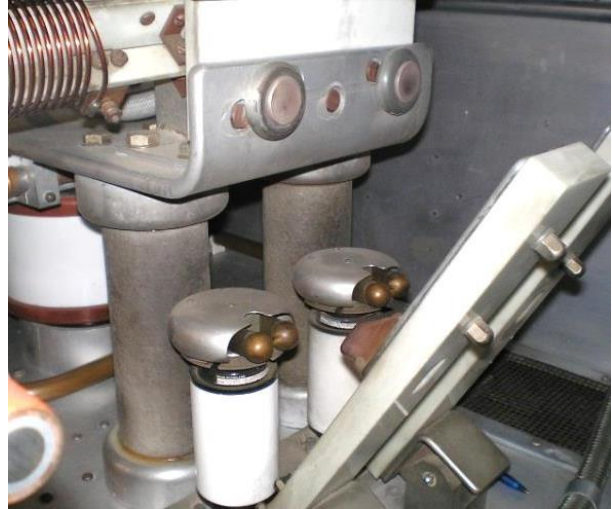
**Figure 3** shows a pair of low-value fixed vacuum capacitors that are pneumatically operated as required. The switch blade is effectively a small inductor in series with the capacitor. Note the use of coronal-shielded ball contacts for the lower connection and a contact pad with an associated pad (out of sight) for the point-of-contact upper RF connection. The blade is secured by M6 studs and round dome-head nickel-plated brass nuts rather than regular hexagon nuts, again to minimise corona.

The support structure is once again substantial, rounded-edge aluminium plate, gently bent to 90° affixed to insulators that themselves have rounded mounting terminations top and bottom.

**Figure 3. Anti-parasitic capacitor fixings in the MCSL B6124 300 kW final RF amplifier**

For amateur use, it is possible to copy the way MCSL designed a feed-through connection for a fixed neutralising capacitor, *i.e.* to cut a 37 mm hole in the chassis and across it bolt an insulating sheet. Through the sheet over the centre of the hole run a length of, say, 4 BA studding bolted each side and connect to either end.

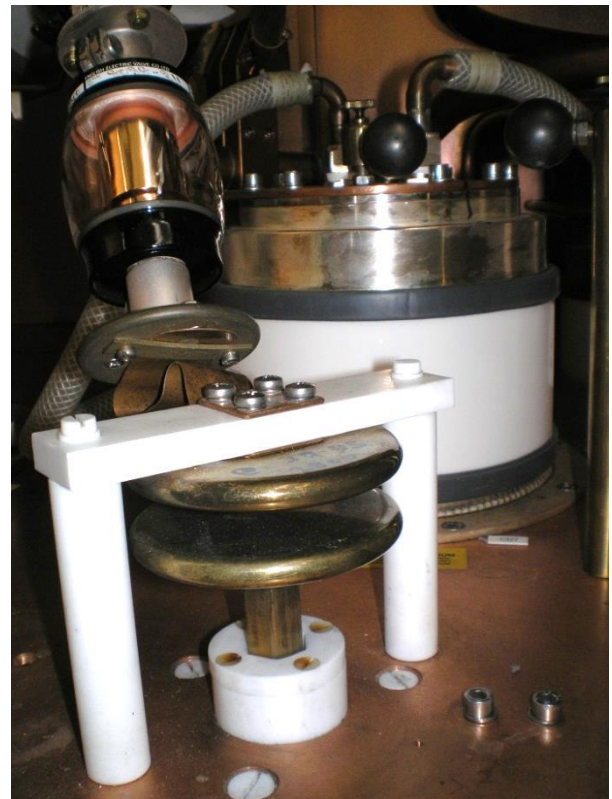
**Figure 4. RIZ 250 kW sender showing motorised neutralising capacitor etc**

The use of PTFE material as an HV insulating medium is illustrated in **Figure 4**. The motorised neutralising capacitor is formed by two smooth rounded disks where one is fixed and attached by round head stainless steel bolts to the PTFE support with a copper tail up to the end of a series pair of 25 pF, 50 kV vacuum capacitors. These have a circular smooth-edged terminating plate. The moving neutralising disk is within a further PTFE

assembly which affords both high voltage isolation through the chassis and a low friction medium for the mechanical motion. The Croatian RIZ Transmitter Company use countersunk stainless steel screws and Allen screws with domed nuts or straight into threaded bosses in high voltage areas. They also employ large cabinets with plenty of spacing for HV and RF assemblies. For HV distribution, RIZ often do as MWT and MCSL (successor to MWT) did by using the inner of RG8/URM67 50  $\Omega$  coaxial cable as a wire, sometimes leaving the outer copper and plastic insulation hence making a screened DC lead with an exposed tag/insulated end of some 6 inches and terminating the outer to chassis.

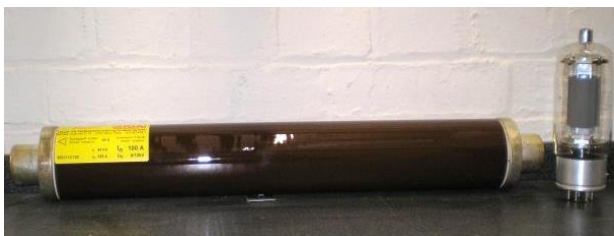
**Figure 5. A SIBA plug-in fuse with an 813 tube for comparison**

**Figure 5** shows the plug-in SIBA fuse alongside an 813 valve for comparison. The outer coating on the ceramic body is highly polished and the end caps are silver-plated and have rounded edges.

In the RIZ 250 kW senders, a separate cubicle was provided within which are three 11 kV AC vacuum switches, to switch the sender on and off, and three 11 kV AC fuses. The incoming 11 kV AC mains passes first through the vacuum switches and then out through the trio of fuses to the primary of the main HV transformer. These particular fuses are manufactured by the German Company SIBA. The main HV transformer has three separate secondaries, each with 48 separate 800 VAC windings and four 400 VAC windings, for the digitally controlled modulator assembly [1].

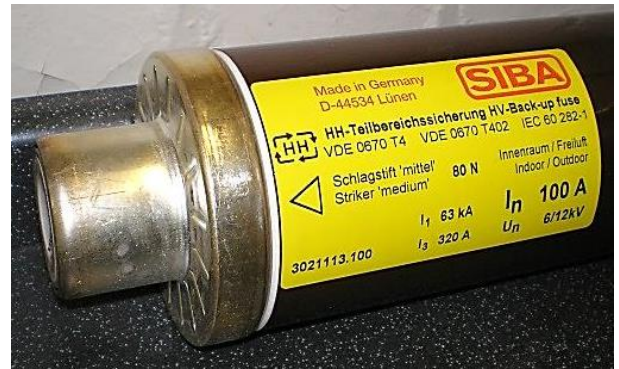
**Figure 6. SIBA fuse type designation label**

The rating label of this particular fuse (**Figure 6**) shows the following: SIBA, Made in Germany, D-44534 LÜNEN. It is described as *HH Teilbereichssicherung, HV Back-up fuse*. The maximum running current is 100 A and the voltage rating is 6–12 kV. The maximum rated fault-breaking rupture current is 63 kA. It is suitable for indoor and outdoor use.

Reference is made to 'striker-medium' followed by '80 N' so whether the interruption is assisted within the body by some sort of mechanism with a release force of 80 Newtons is open to further research and conjecture.

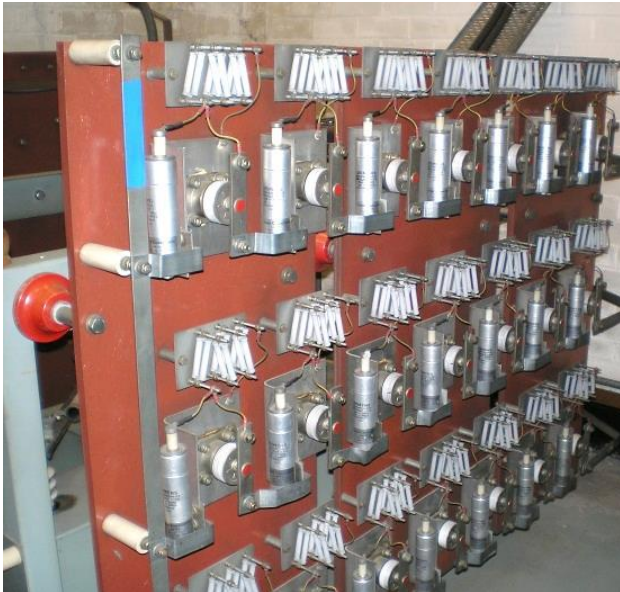
**Figure 8. Individual diode and suppression modules**
